Failure Analysis of Condenser Tube in Unit 1 of the Tenayan Steam Power Plant 2 X 110 MW

Abstract—This study conducted a failure analysis of the condenser tube in unit 1 of the Tenayan Steam Power Plant. It started from the inspection in the first year after the commercial off date (COD) where there is a leaky tube, so there is further suspicion. Various tests and analysis are carried out such as tube vacuum testing, Eddy current testing, condenser tube material analysis, condenser water quality analysis, effectiveness and heat transfer on a condenser to the determination of root cause failure analysis to ensure condenser performance. From the results obtained, the cause of the failure of the condenser tube in unit 1 is the thinning of the condenser tube wall. The failure mechanism is erosion corrosion caused by the use of water in condensers that contain high turbidity.

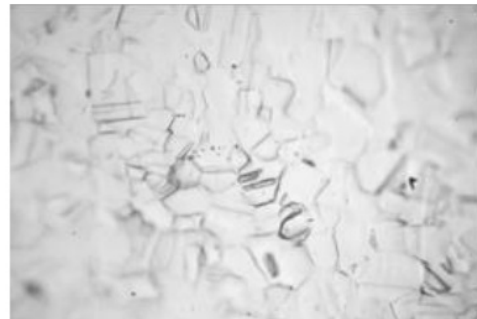
Test results of the chemical composition of the tube material are shown in Table II. When viewed from the composition test results based on the alloy elements contained in the material is almost the same as the SS304 material [13]. The microstructure analysis of the tube material was then performed as shown in Figure 2. The microstructure image of the tube material is matched with the microstructure of the SS304 material using ASM Handbook Metallography and Microstructures [13]. The microstructure image obtained is a condenser tube material that has been used for 3 years with a maximum working temperature of 80 °C.

Fig. 2. The microstructure results from the condenser tube, 400X magnification.

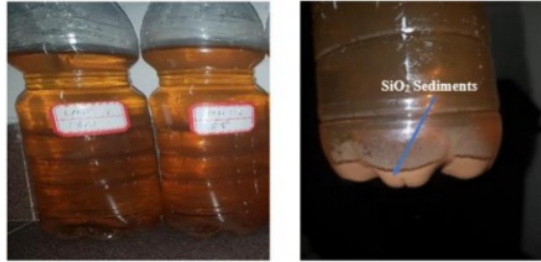
NTU, where this value exceeds the standard that is <15 NTU. Tests were also carried out on cooling water and turbidity values obtained 227.86 NTU and Total Suspended Solid (TSS) 236 mg/L. The application of chemicals in the water treatment system has not been maximized and solid particles from the Siak river water are still carried away, which can be seen in Figure 3.

Fig. 3. Condition of Air Cooling Tower

It is recommended to use water for condensers using a closed cycle where the water used comes from the water treatment system and not from the river anymore.
