Failure Analysis of Condenser Tube in Unit 1 of the Tenayan Steam Power Plant 2 X 110 MW

Abstract—This study conducted a failure analysis of the condenser tube in unit 1 of the Tenayan Steam Power Plant. It started from the inspection in the first year after the commercial off date (COD) where there is a leaky tube, so there is further suspicion. Various tests and analysis are carried out such as tube vacuum testing, Eddy current testing, condenser tube material analysis, condenser water quality analysis, effectiveness and heat transfer on a condenser to the determination of root cause failure analysis to ensure condenser performance. From the results obtained, the cause of the failure of the condenser tube in unit 1 is the thinning of the condenser tube wall. The failure mechanism is erosion corrosion caused by the use of water in condensers that contain high turbidity.

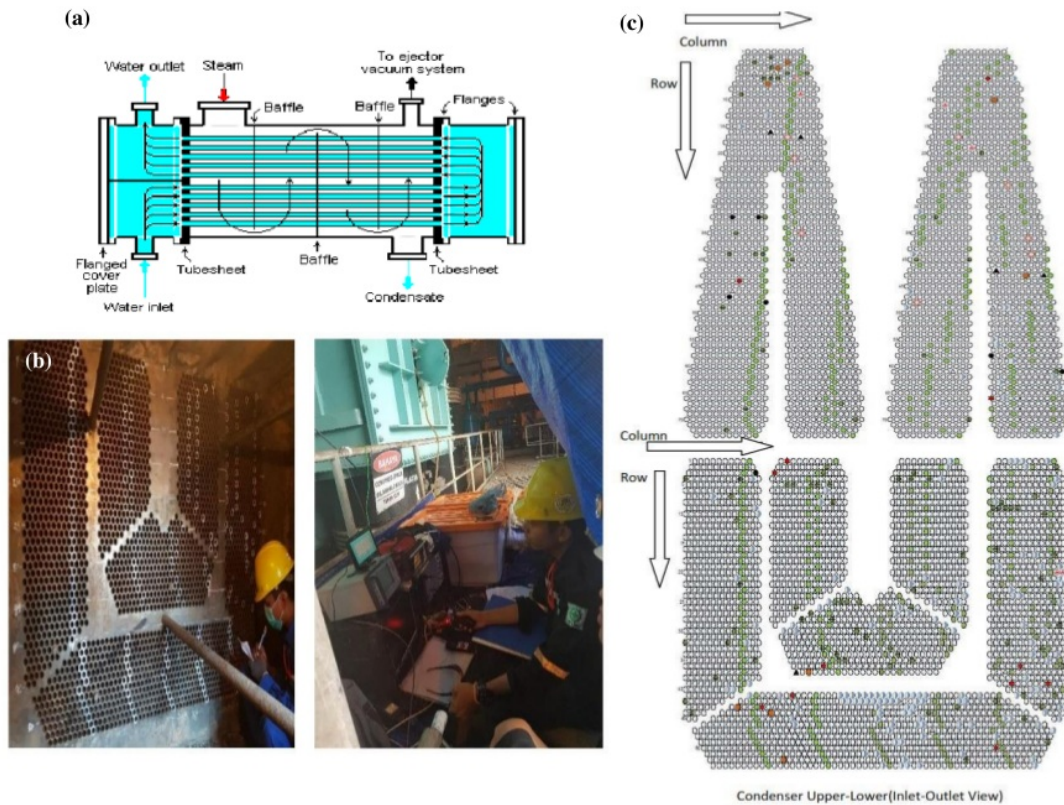
The condenser is a component that works to convert steam into water and be reused [5]. The change process is carried out by flowing current into the room that contains the pipe. Steam flows outside the pipe while water as coolant flows through the inside of the pipe as the scheme shown in Figure 1 (a). Water requirements for cooling in the condenser are very large, so planning is usually taken into account. Cooling water is taken from sources that have enough water, such as lakes or the sea.

coordinates, Row number and Tube number following the tube sheet configuration. Furthermore, plotting the X-Y coordinates is adjusted to the segmentation as shown in Figure 1 (c).

Fig. 1. (a) condenser scheme, (b) arrangement of condenser tubes, (c) plotting and marking condenser tubes
